DEGRADATION OF HUBBLE SPACE TELESCOPE METALLIZED TEFLON® FEP THERMAL CONTROL MATERIALS

Patricia A. Hansen, Jacqueline A. Townsend NASA/Goddard Space Flight Center Greenbelt, Maryland 20771

ABSTRACT

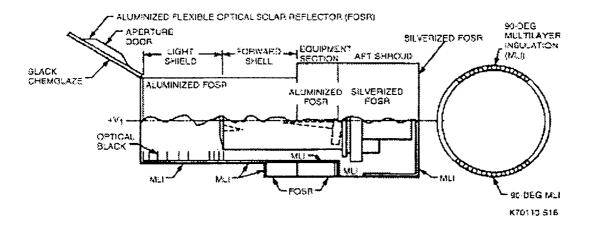
Figure 2: HST Thermal Control Subsystem Materials Location Map

The HST uses several thermal control materials to passively control temperatures on-orbit. These materials are of two primary types: radiators and MLI blankets. As shown in Figure 2, the radiator surfaces are the AS, Aft Bulkhead, AD, and SSM Bays and louvers on the SMM Bays. The radiator surfaces are 5 mil Teflon® FEP/Ag/Inconel bonded to the vehicle substrate (aluminum) with acrylic adhesive. All other surfaces are blanketed.
